**DEPARTMENT OF TRANSPORTATION**

Contract #: 04-0120F4Cty: SF/ALA Rte: 80 PM: 13.2/13.9File #: 69.28**WELDING INSPECTION REPORT****Resident Engineer:** Pursell, Gary**Address:** 333 Burma Road**City:** Oakland, CA 94607**Report No:** WIR-012025**Date Inspected:** 17-Feb-2010**Project Name:** SAS Superstructure**OSM Arrival Time:** 700**Prime Contractor:** American Bridge/Fluor Enterprises, a JV**OSM Departure Time:** 1900**Contractor:** Zhenhua Port Machinery Company, Ltd (ZPMC), Changxing Island **Location:** Shanghai, China**CWI Name:** Li Yang**CWI Present:** Yes No**Inspected CWI report:** Yes No N/A**Rod Oven in Use:** Yes No N/A**Electrode to specification:** Yes No N/A**Weld Procedures Followed:** Yes No N/A**Qualified Welders:** Yes No N/A**Verified Joint Fit-up:** Yes No N/A**Approved Drawings:** Yes No N/A**Approved WPS:** Yes No N/A**Delayed / Cancelled:** Yes No N/A**Bridge No:** 34-0006**Component:** OBG**Summary of Items Observed:**

## WELDING INSPECTION REPORT

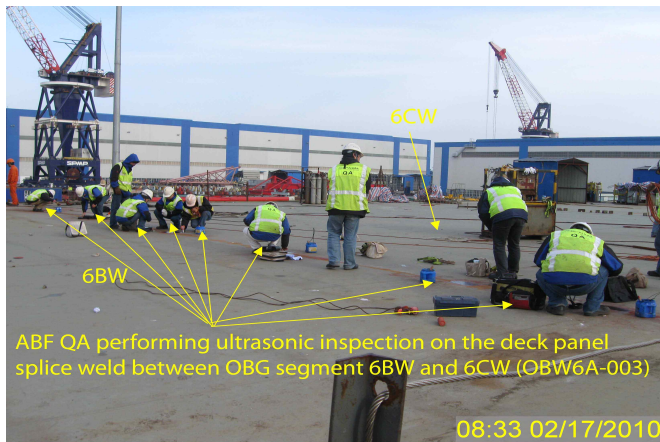
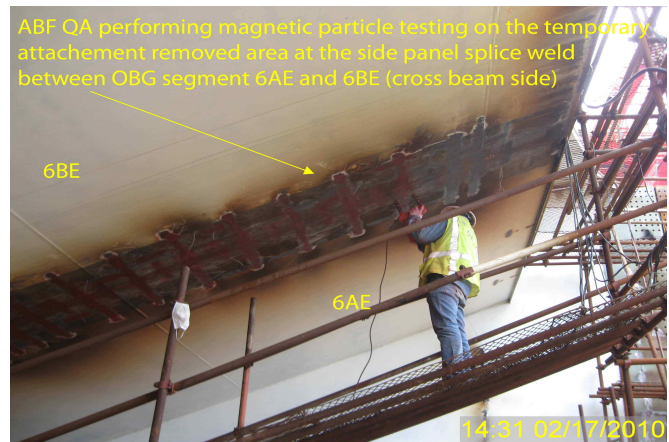
This QA Inspector Witnessed ABF personal performing Magnetic particle Testing (MT) on weld between side panel and bottom panel weld are identified as SEG0278-031. American Bridge Fluor (ABF) request number was 02162010-1.

No relevant indication were observed during MT
